## WALLS & CEILINGS

# WALL & CEILING FINISHES

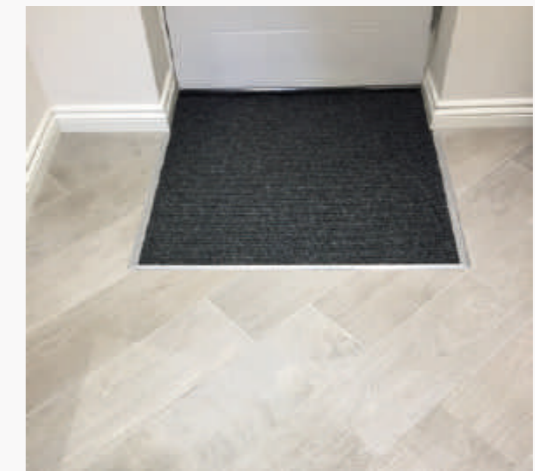
- 1 Setting out of corners, duct casing, access covers and any associated framing must be square, neat and tidy, and provided with an appropriate decorative finish.
